APPENDIX B
NATURAL ENVIRONMENT STUDY REPORT

Natural Environment Study Report

Nicholas Pond Trail ADA Improvement Project

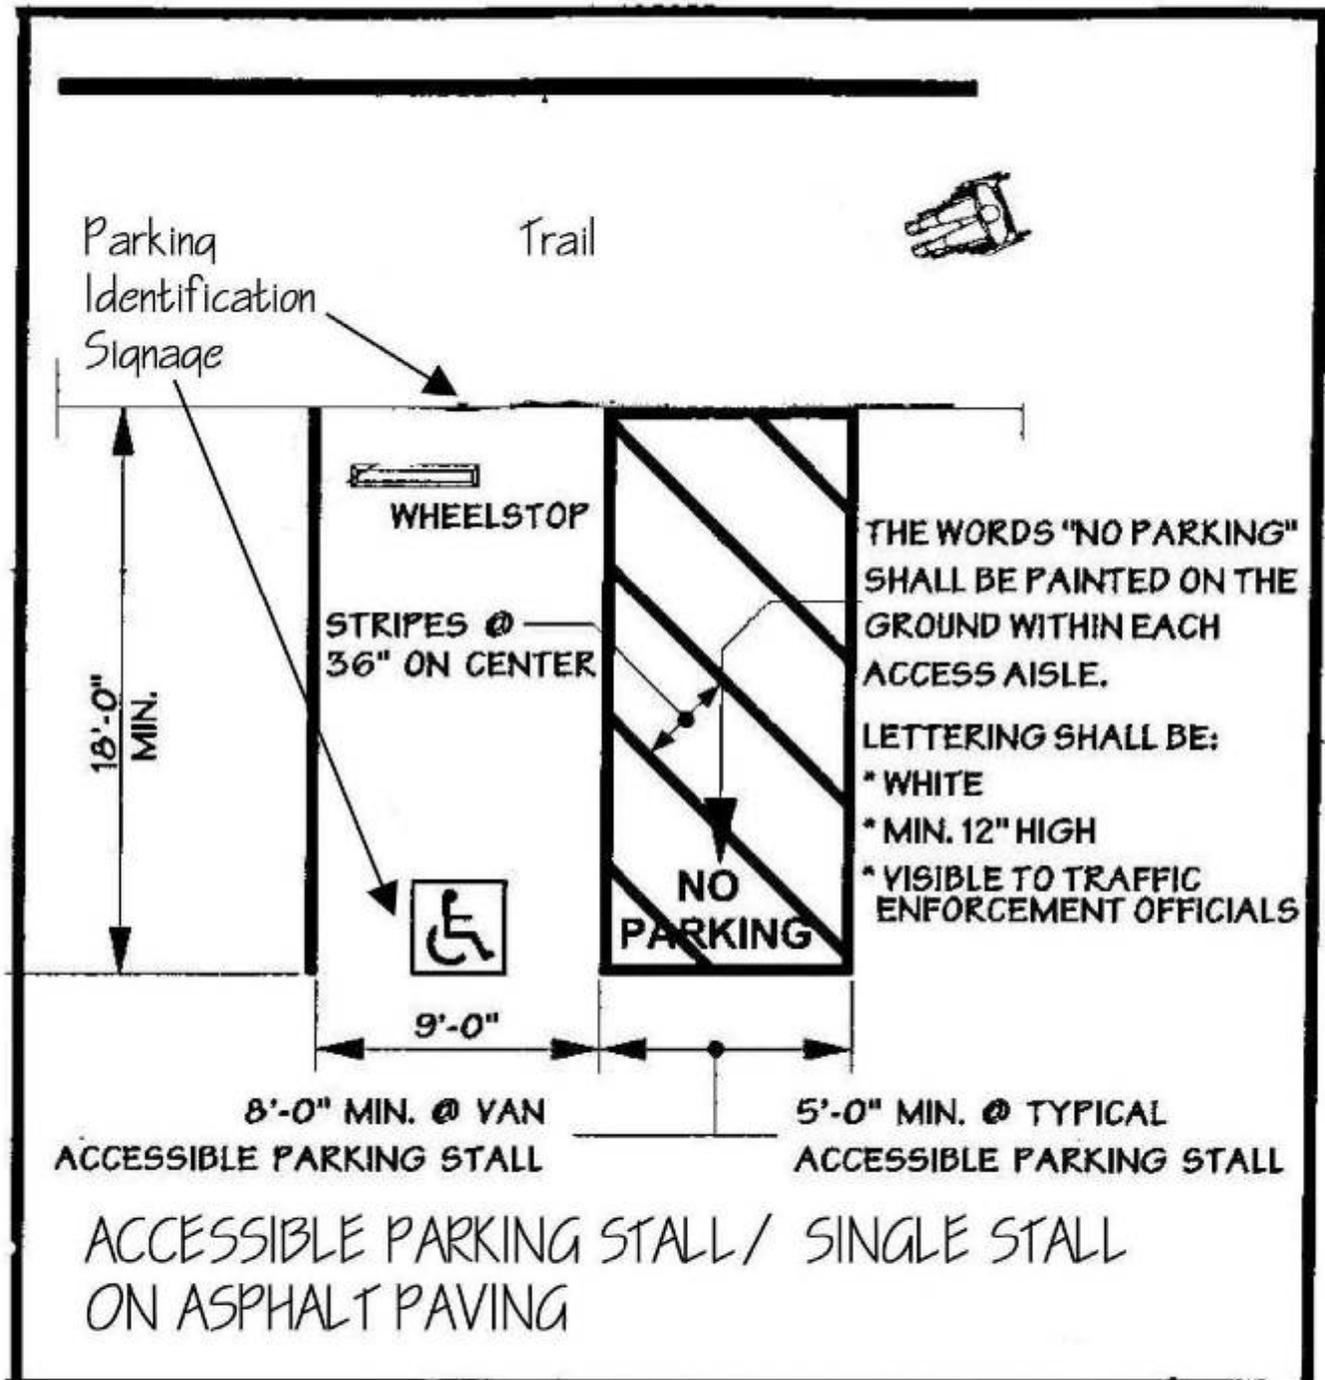
Figure 4. Overview and Details of the Proposed Nicholas Pond Trail ADA Improvement Project, Leo Carrillo State Park.

- **Parking Space** - One accessible parking space (5.5 m x 5.0 m [18 ft x 17 ft]) and a small, concrete retaining wall (30.5 cm [12 in] high) would be constructed in the cul-de-sac at the end of Decker School Road, near the entry to Nicholas Pond Trail (Figures 4, 16, and 20).

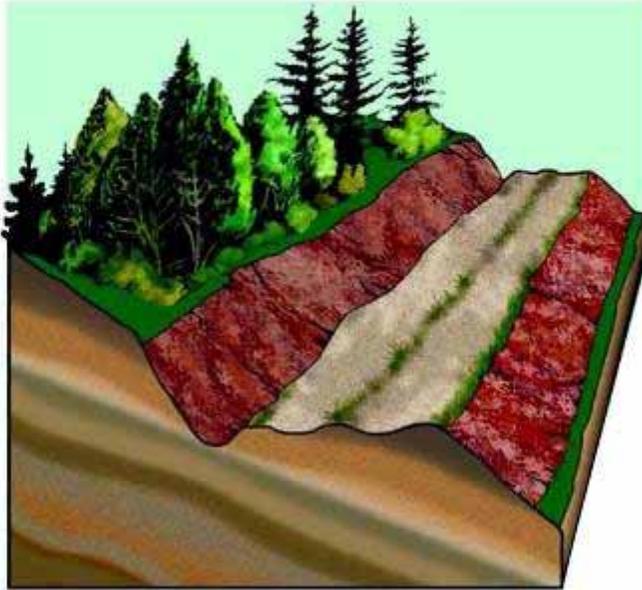
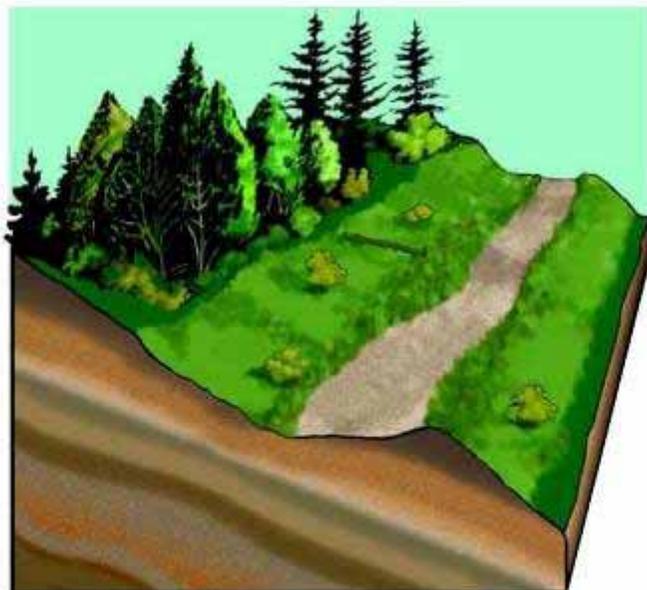
ROAD TO TRAIL CONVERSION

Many trails within State Parks are developed on legacy roads that were constructed before the area became public land. Early park managers found it was much easier to let a road close in with vegetation and become a trail, than to construct a new trail. Where roads did not connect, short trail segments were often built to link the roads into a trail network. Unfortunately, poorly constructed roads make poor trails. Grades are often excessive, and many of these roads continue to be sources of sediment and erosion problems. Roads that are unsuitable as trails are removed by full recontouring or decommissioning. Where roads do provide a suitable trail alignment, the road can be converted to a trail. Conversion greatly reduces erosion problems and provides park visitors with a more pleasant hiking experience.

A road-to-trail conversion transforms an existing road into a recreational trail using heavy equipment. The process begins by removing encroaching vegetation from the roadway and stockpiling it nearby. Then the dozer rips the inboard ditch and inboard road surface to reduce ditch memory and increase the permeability of the roadbed. Once the roadbed is prepared, embankment fill is excavated from the outboard edge of the road and placed against the cutbank. Between the excavated fill and the cutbank fill, a 5-foot wide portion of the original road is preserved and will serve as the trail tread. The trail should be located on the cutbench of the road, not on the embankment fill. This ensures the trail is on stable well-compacted material. The trail can be constructed with gentle meanders to soften the appearance of a straight road section.

- **Road to Trail Conversion** – Approximately 436 m (1,430 ft) of existing dirt road, extending from the trailhead south to Nicholas Pond, would be reduced in width from roughly 2.4 m (8 ft) to 1.2 m (4 ft). This section of trail served as an old fire road that was periodically graded by the previous property owner to ensure vehicle passage. Due to grading, a berm of soil has accumulated on the west or downslope side of the road, altered the natural water flows, and caused incising along the inside of the roadway and at certain locations into the creek. As a means of correcting the situation, work would involve using a cut and fill method to transfer the banked/mounded soils to the inside slope; backfilling gullies/ditches and narrowing the original road corridor. The technique would recreate a more natural, sloping hillside that would extend out to the creek,

thereby improving sheet flow into the drainage and eliminating erosional problems (Figures 5-6 and 21-22).

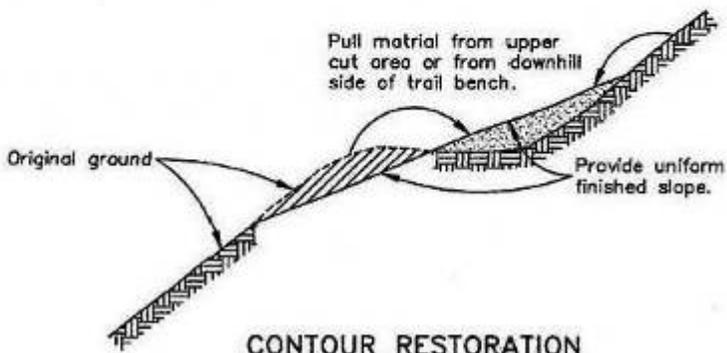
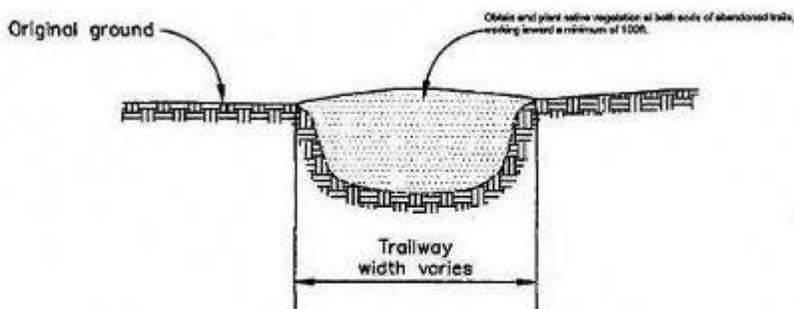
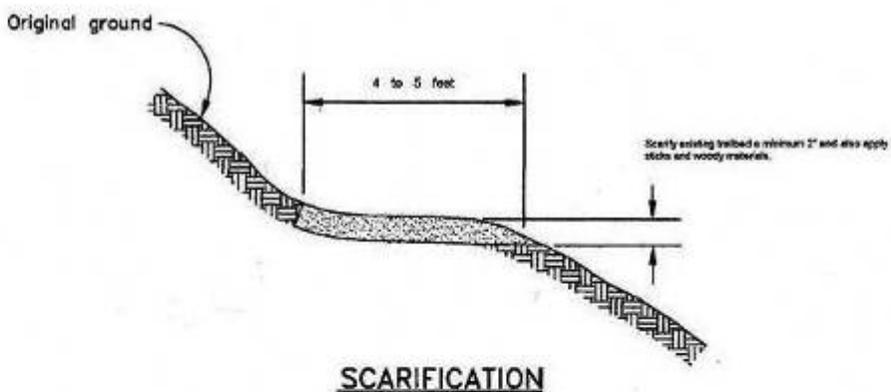
Figure 7. Overview and Details of the Proposed Nicholas Pond Trail ADA Improvement Project, Leo Carrillo State Park.

TRAIL OBLITERATION

TRENCH BACKFILL

- **Road Removal** – A portion of roadway (roughly 197 m [645 ft] long), located slightly northeast of Nicholas Pond, would be abandoned to allow for an ADA trail reroute. Soils underlying the road would be decompacted and regraded, and allowed to naturally revegetate over time (Figures 7-8 and 23).

- **Trail Removal** – Two trail sections (91 m [300 ft]) bordering the western edge of Nicholas Pond (i.e., south of the second bridge and just north of the future overlook) would be removed due to difficulties concerning accessibility. The existing path would be subject to grading/recontouring and closed to the public to prevent potential disturbance (Figures 7-8 and 24).

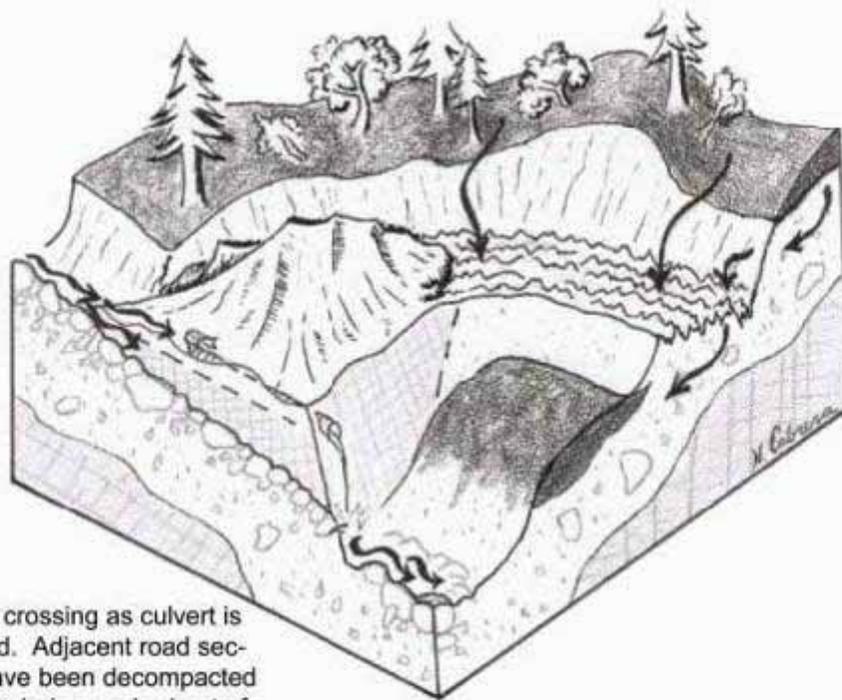
Stream crossing before treatment

- **Stream Improvements** – Work associated with the two bridges would include measures to restore and stabilize the creek. Upstream of the first crossing, an existing culvert and accompanying fill would be removed, thereby eliminating an instream obstruction, reestablishing more natural flows, and preventing head-cutting below the pipe. A series of rock steps would also be placed upstream and downstream of the culvert to control the grade, reduce the intensity of flows, and minimize overall erosion. Additionally, in the area of the second bridge, grading of the channel/tributary would be undertaken and rock step pools would be installed to correct head-cutting and stabilize the stream profile (Figures 17 and 32-33).

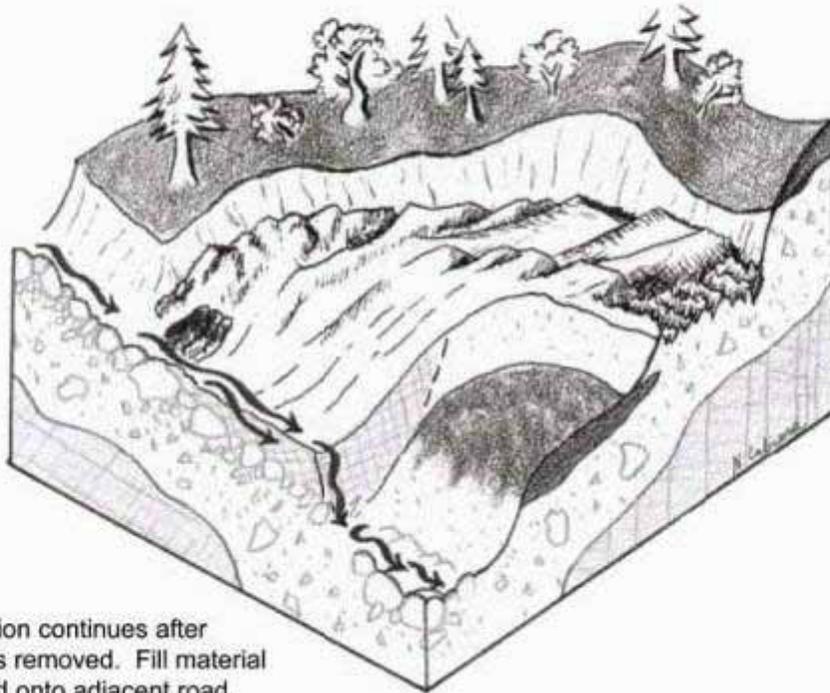
Stream crossing as culvert is exposed. Adjacent road sections have been decompacted and fill is being pushed out of the crossing.

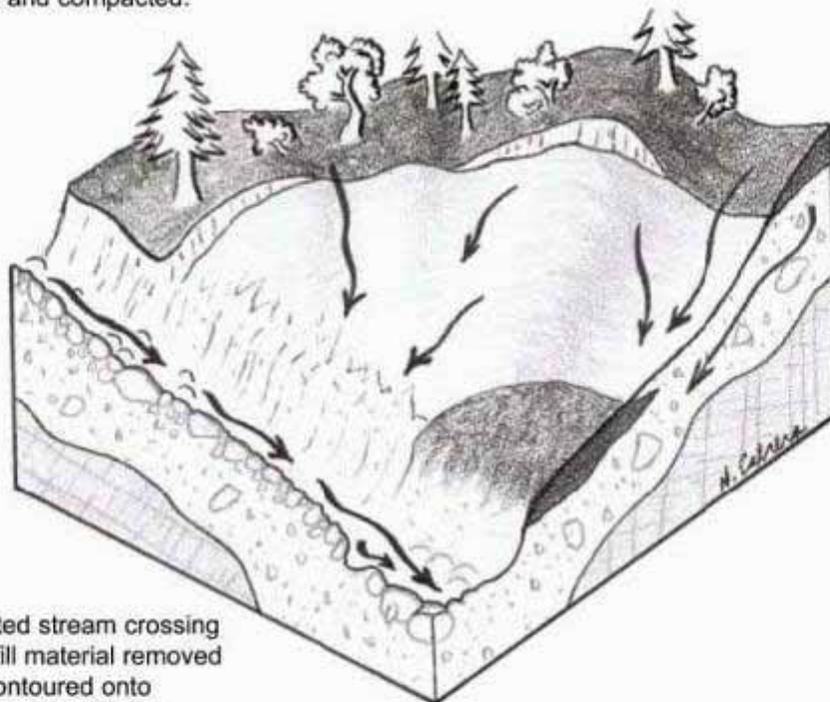
Excavation continues after culvert is removed. Fill material is moved onto adjacent road sections and compacted.

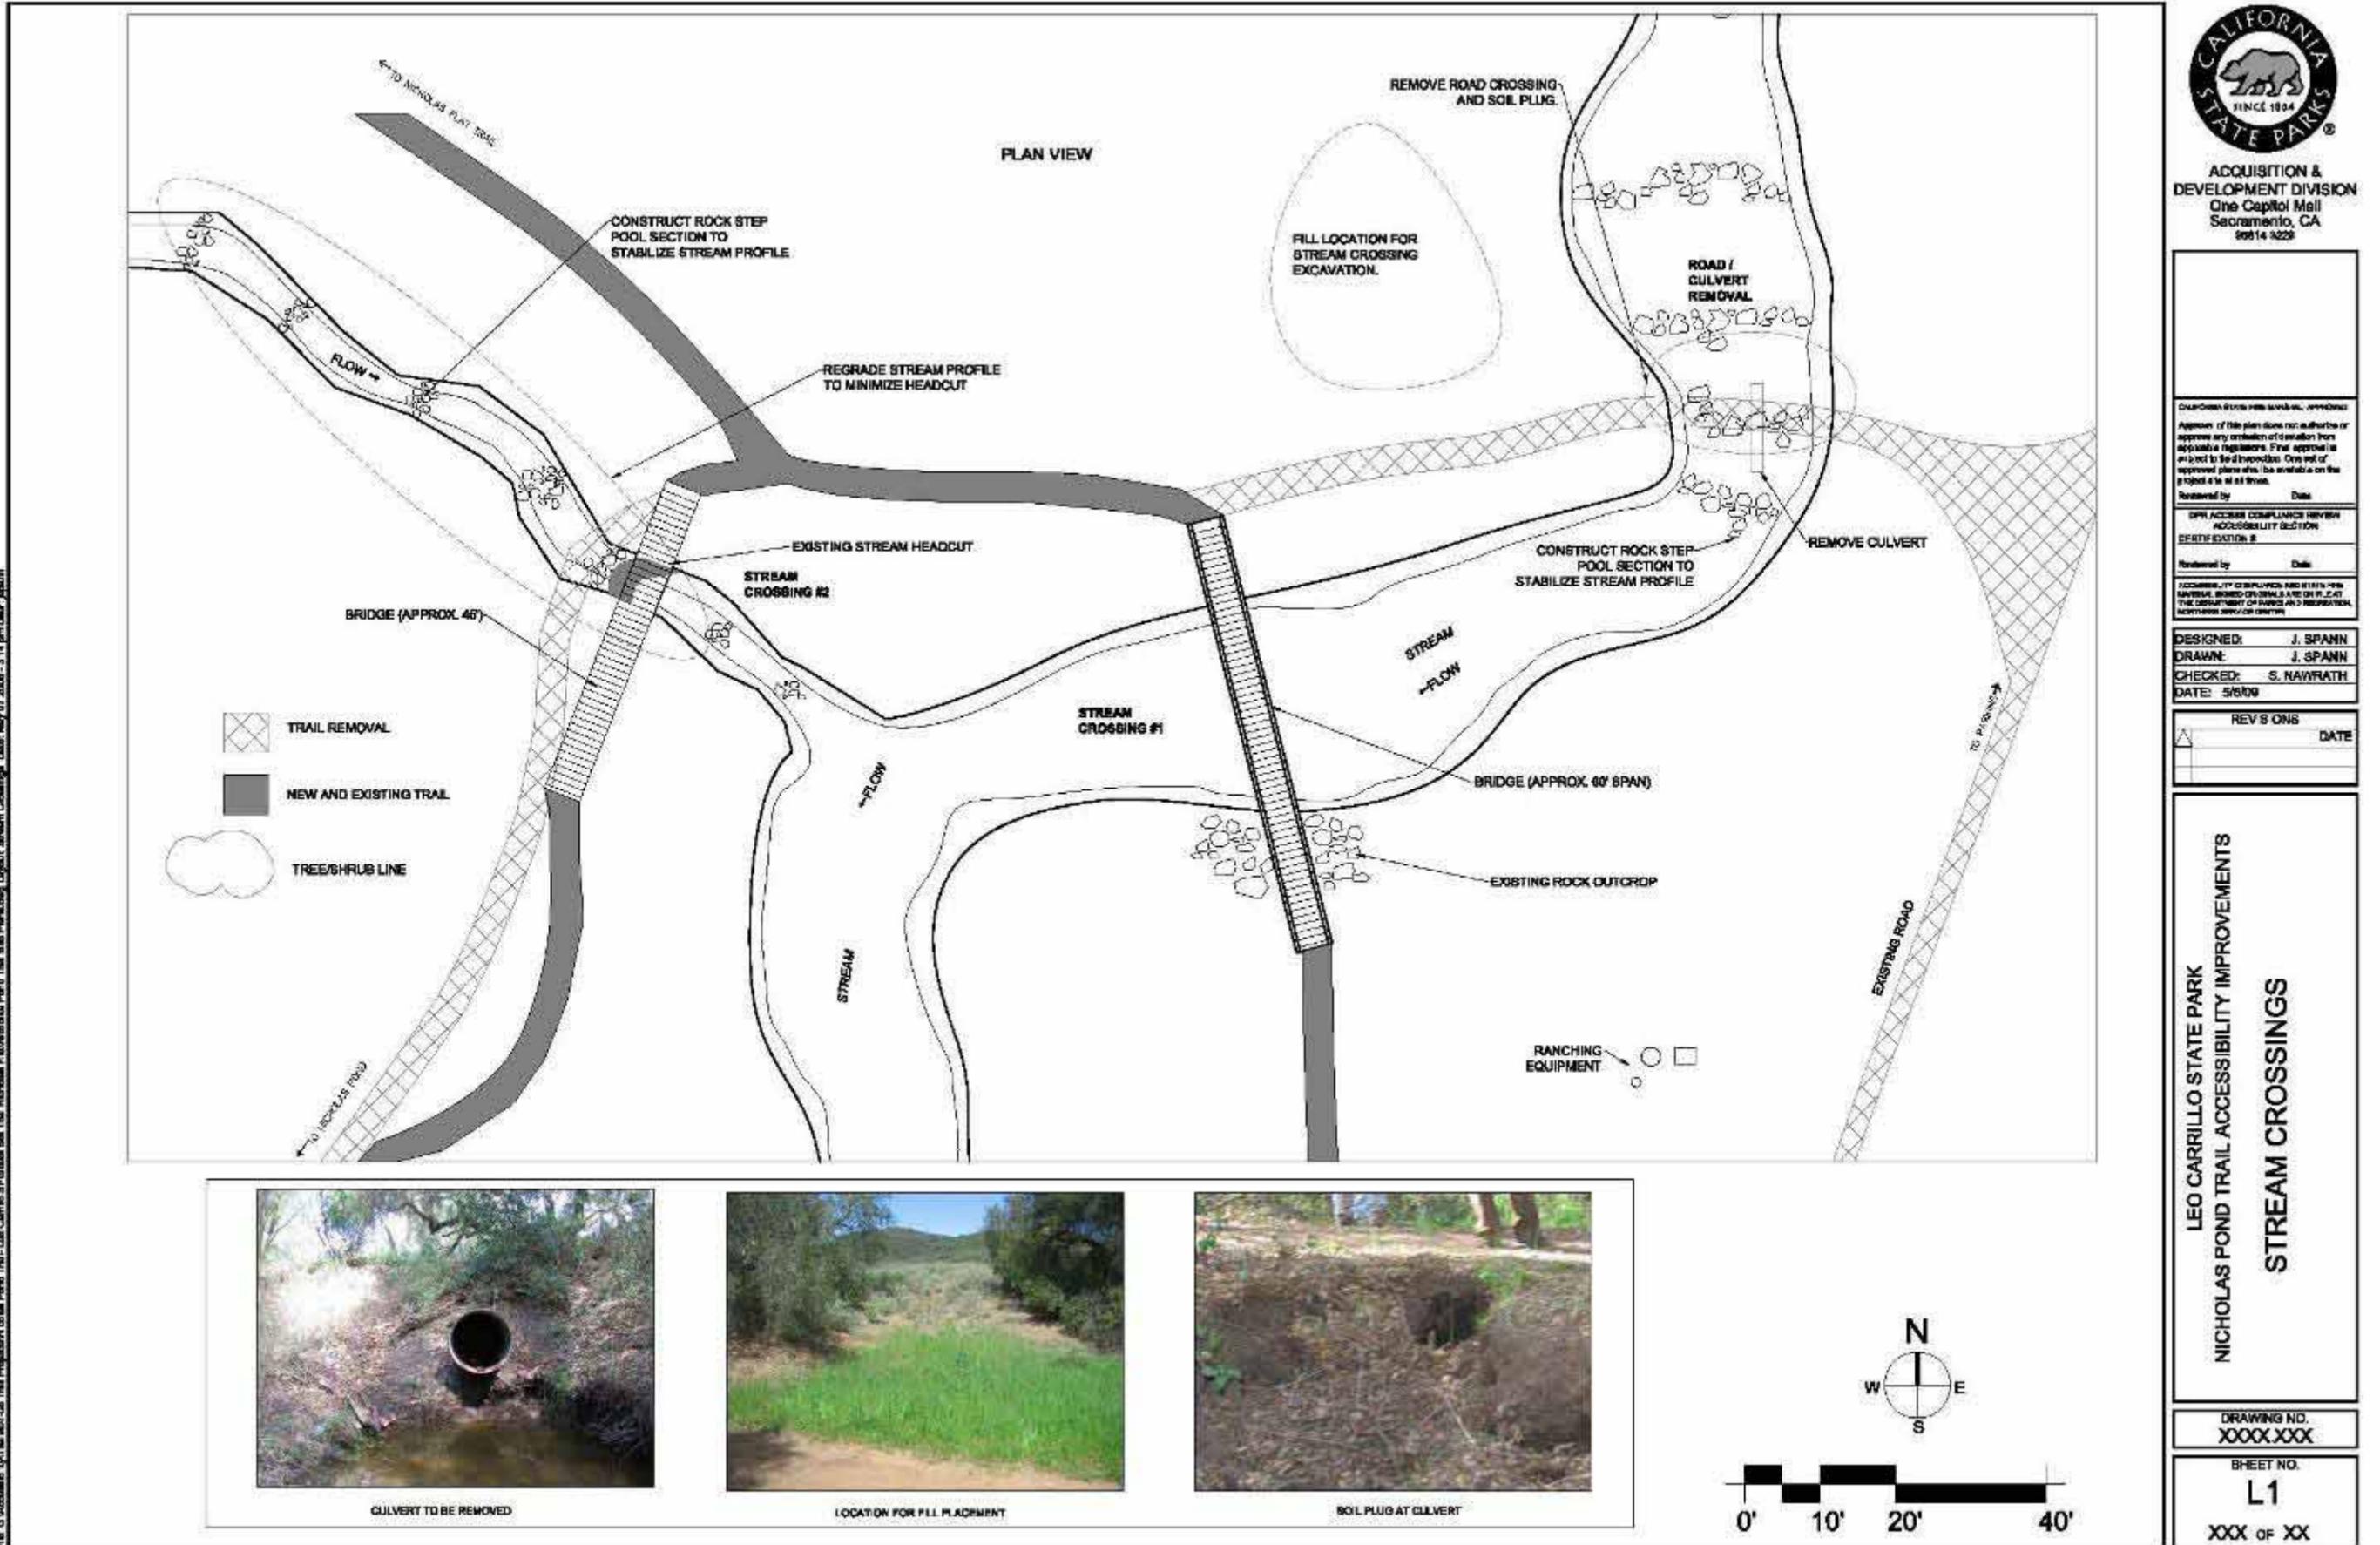
Completed stream crossing with all fill material removed and recontoured onto adjacent road sections.

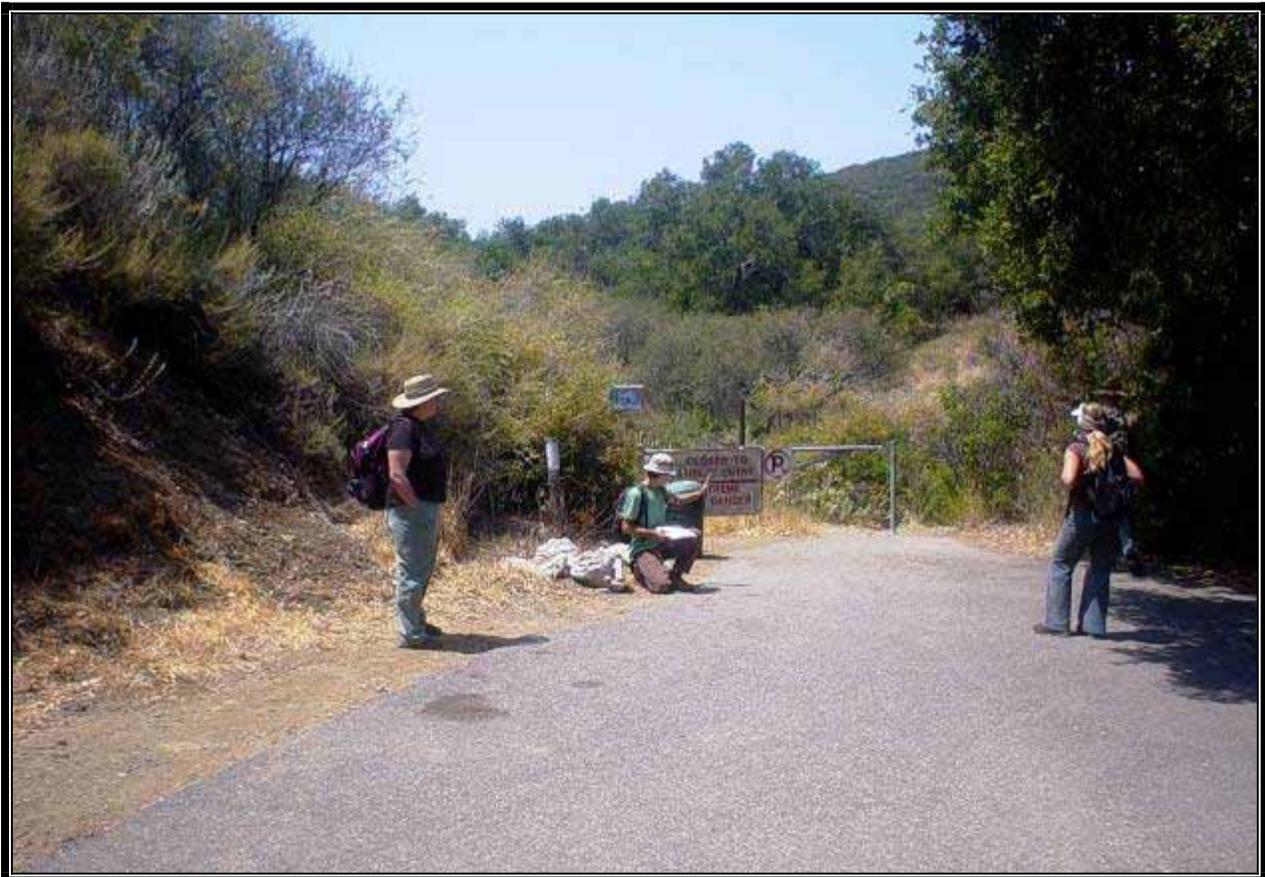
Figure 20. Proposed accessible parking space located at the end of Decker School Road, near the entrance to Nicholas Pond Trail.

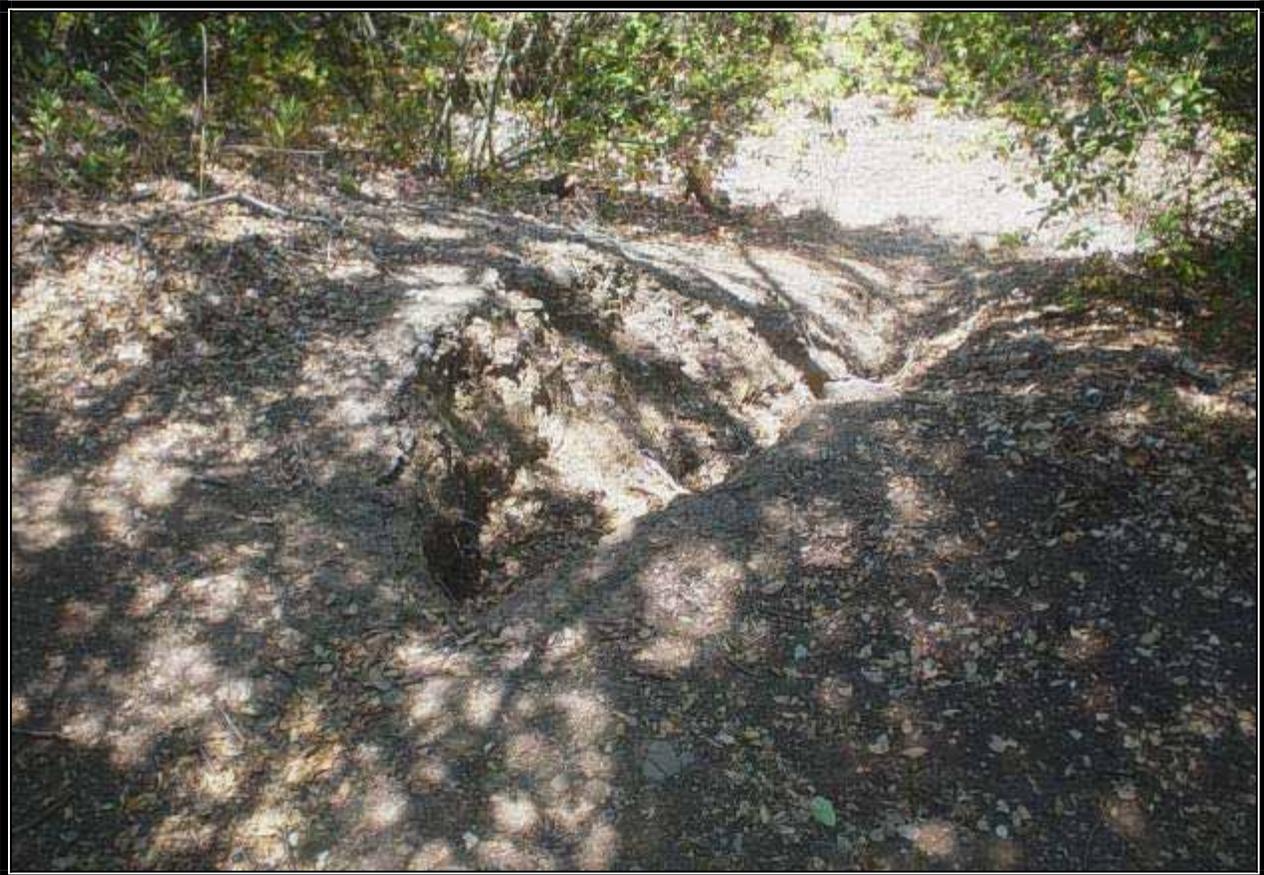
Figure 21. Portion of the 2.4 m (8 ft) wide fire road that would be narrowed to a 1.2 m (4 ft) trail by scraping soils from the bermed, downslope shoulder (right side) and transferring materials to the upslope/inside of the roadway (Gullying and erosion evident in lower left corner of photograph).

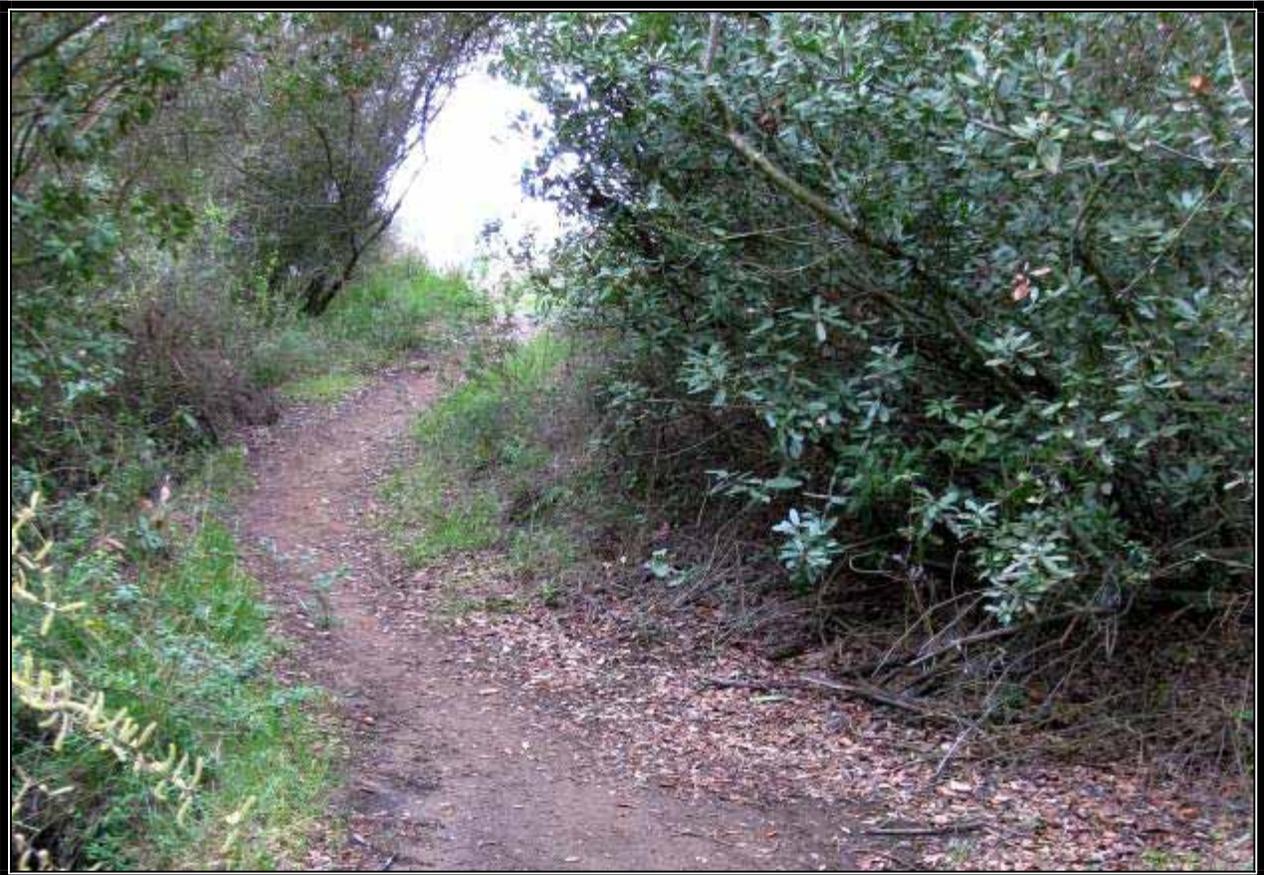
Figure 23. Section of roadway, south of the road to trail conversion, that would be abandoned, regraded, and stabilized with cleared/salvaged vegetation.

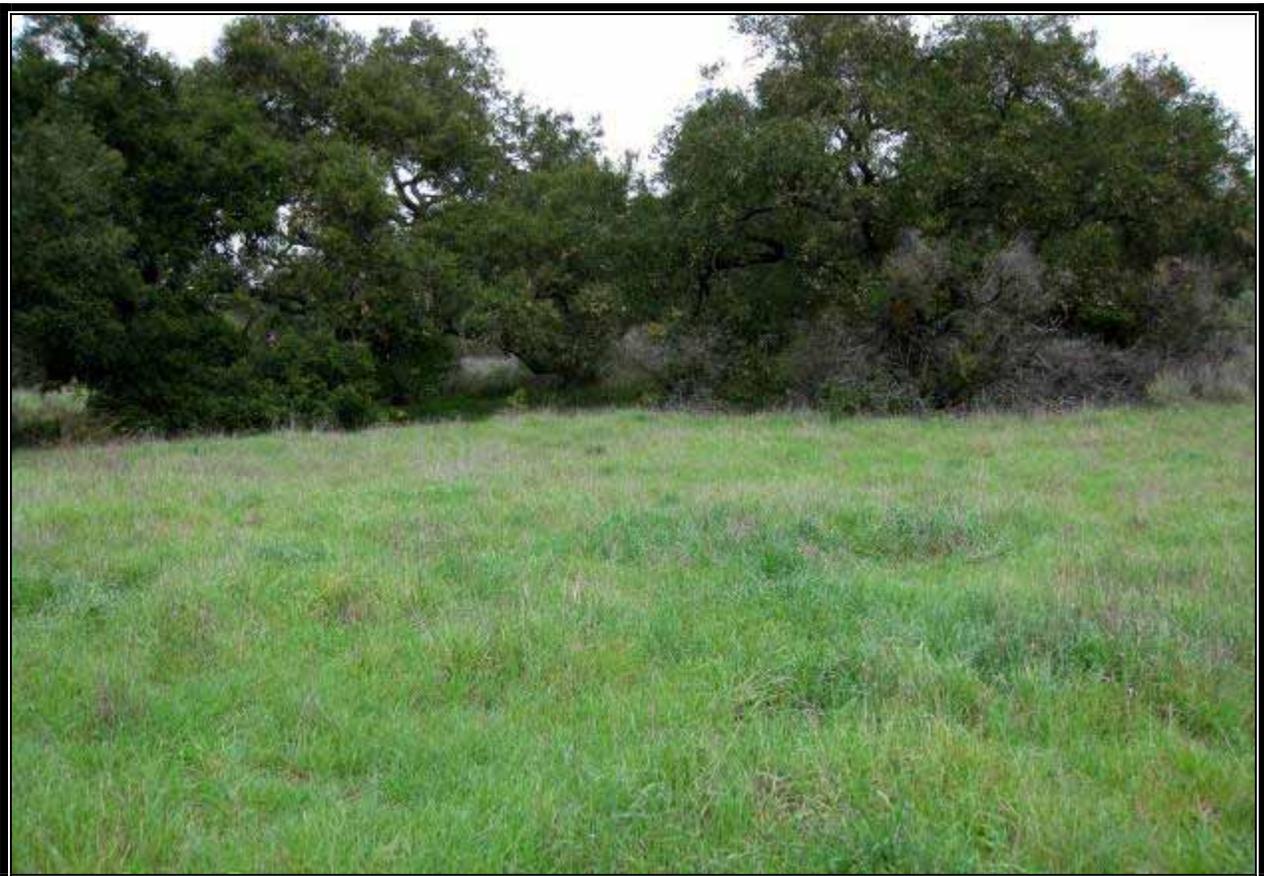
Figure 24. Inclined section of trail, lying south of the second bridge, that would be eliminated from access as part of the ADA improvements.

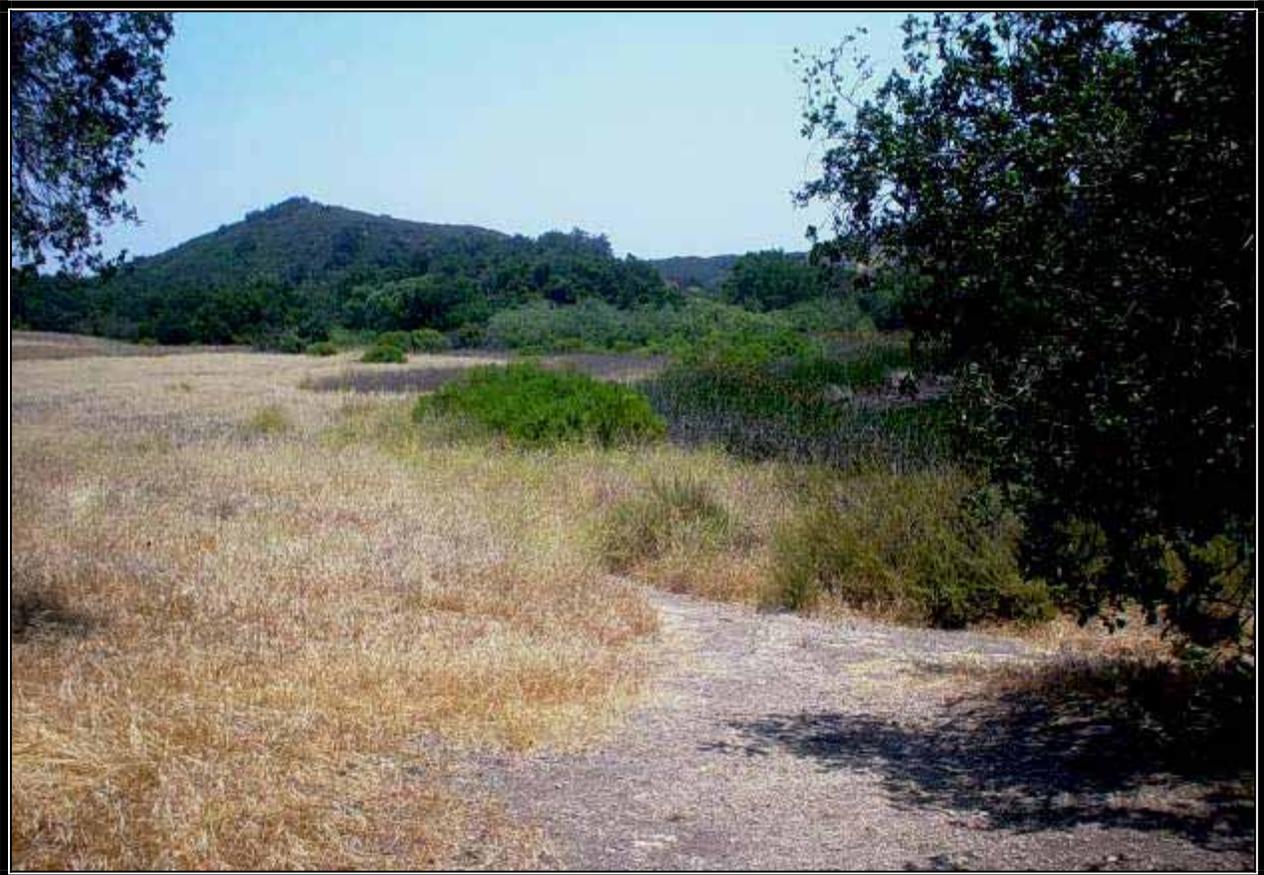
Figure 25. Proposed trail reroute through an area of nonnative grassland and coast live oak woodland, situated south of the road to trail conversion.

- **Trail Reroute** – Approximately 320 m (1,050 ft) of ADA-compliant trails would be created to replace those portions removed from the pathway (Figures 8-9 and 25-26). The three reroutes would be constructed to the north and west of the pond and maintain an overall width of 1.2 m (4 ft).

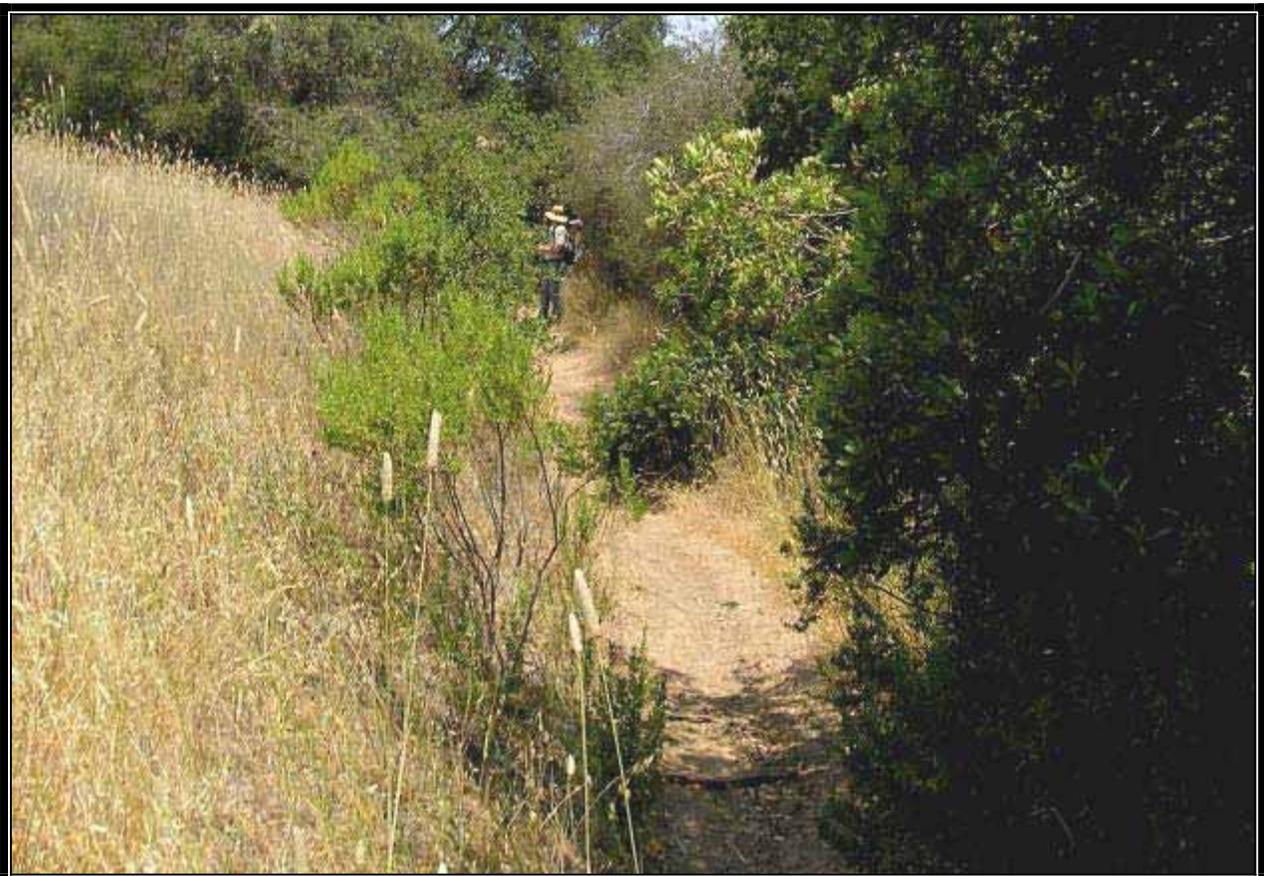
Figure 26. A trail reroute, located near the southern end of the project limits and adjacent to the overlook, that would traverse through a section of nonnative grassland.

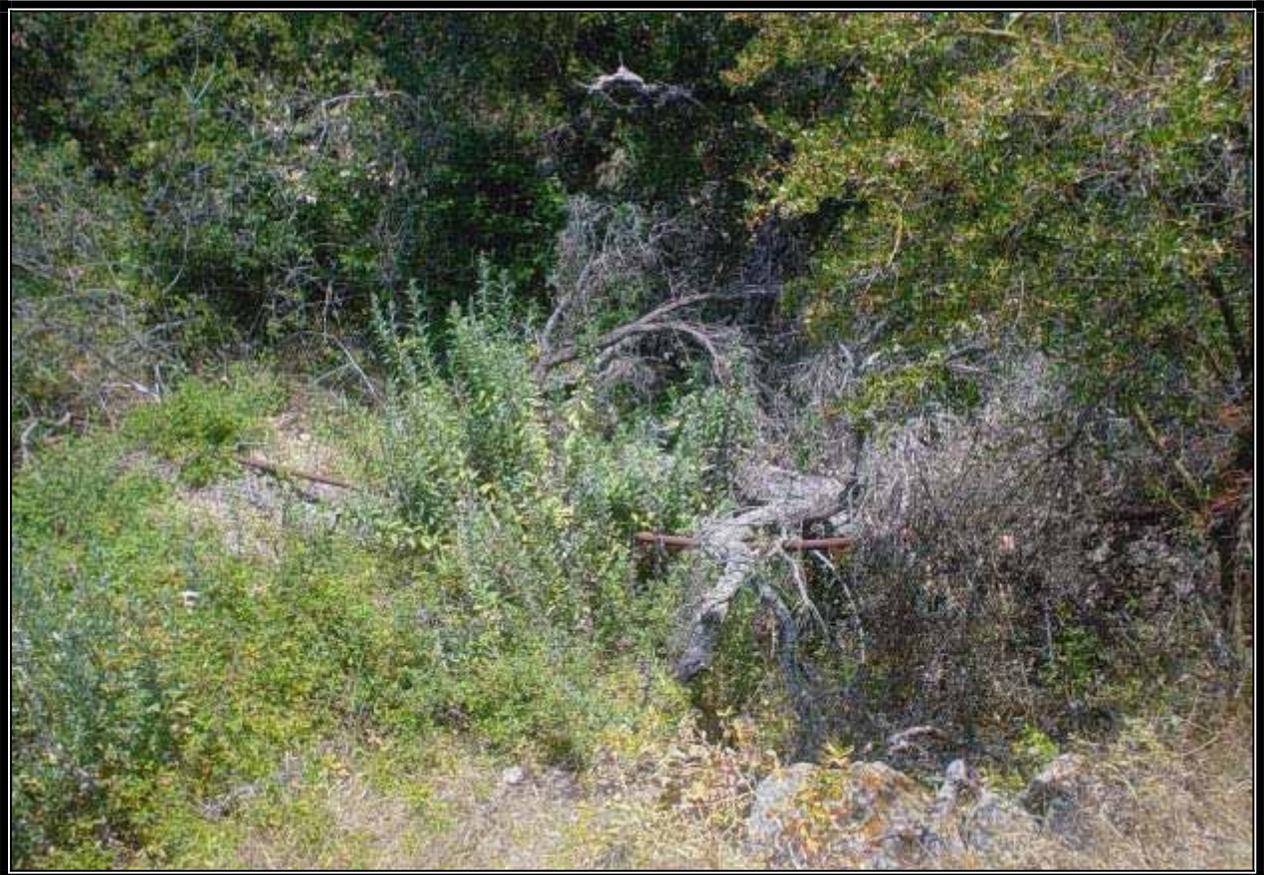
Figure 27. Existing portion of trail, found along the western edge of Nicholas Pond, that would be subject to regrading/reconstruction.

- **Trail Reconstruction** – One segment of existing trail, totaling approximately 149 m [490 ft] in length, would be regraded to provide an accessible path of travel (Figures 9 and 27). The work would serve to establish a 1.2 m (4 ft) wide walkway along the west side of San Nicholas Creek and Nicholas Pond.

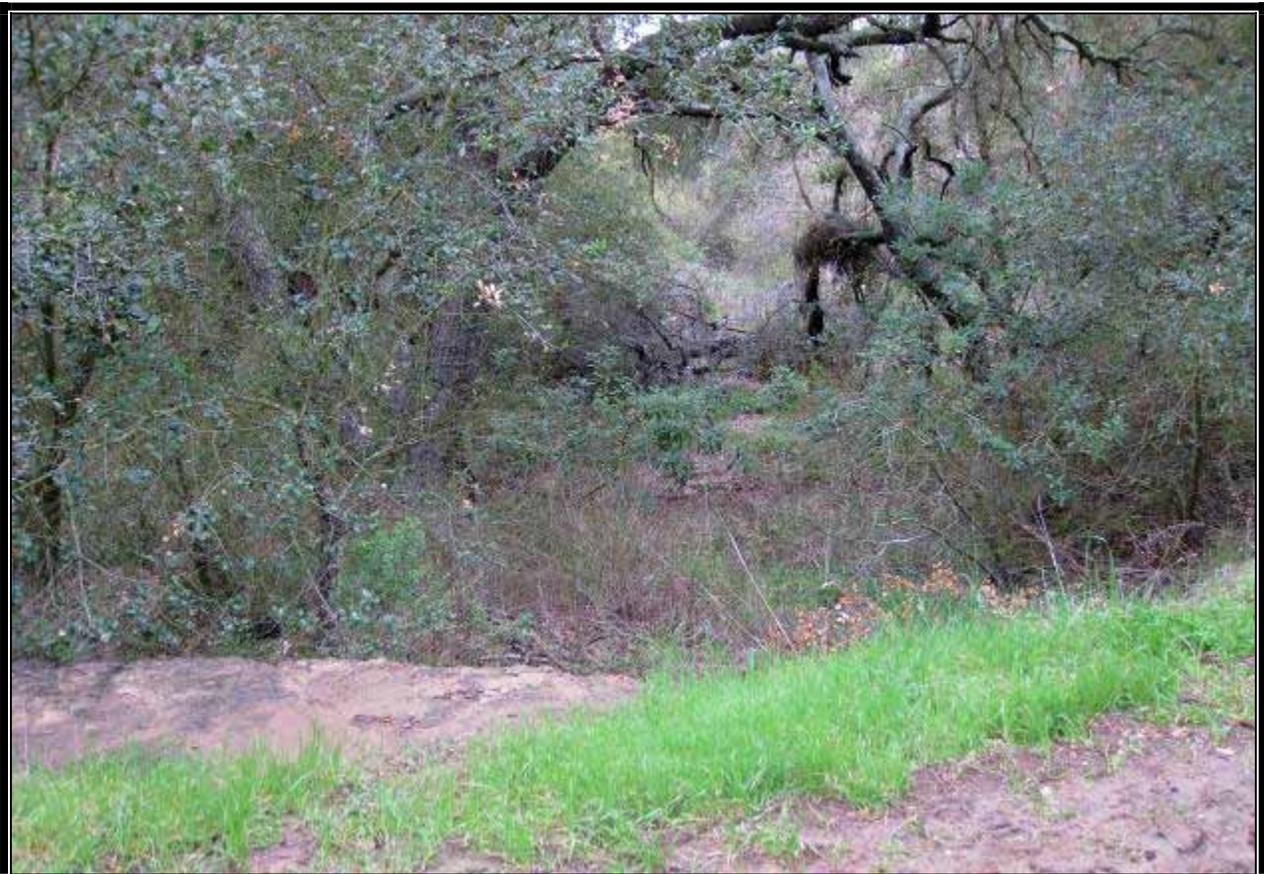
Figure 29. View from existing trail of the proposed northern terminus of the first bridge that would span San Nicholas Creek.

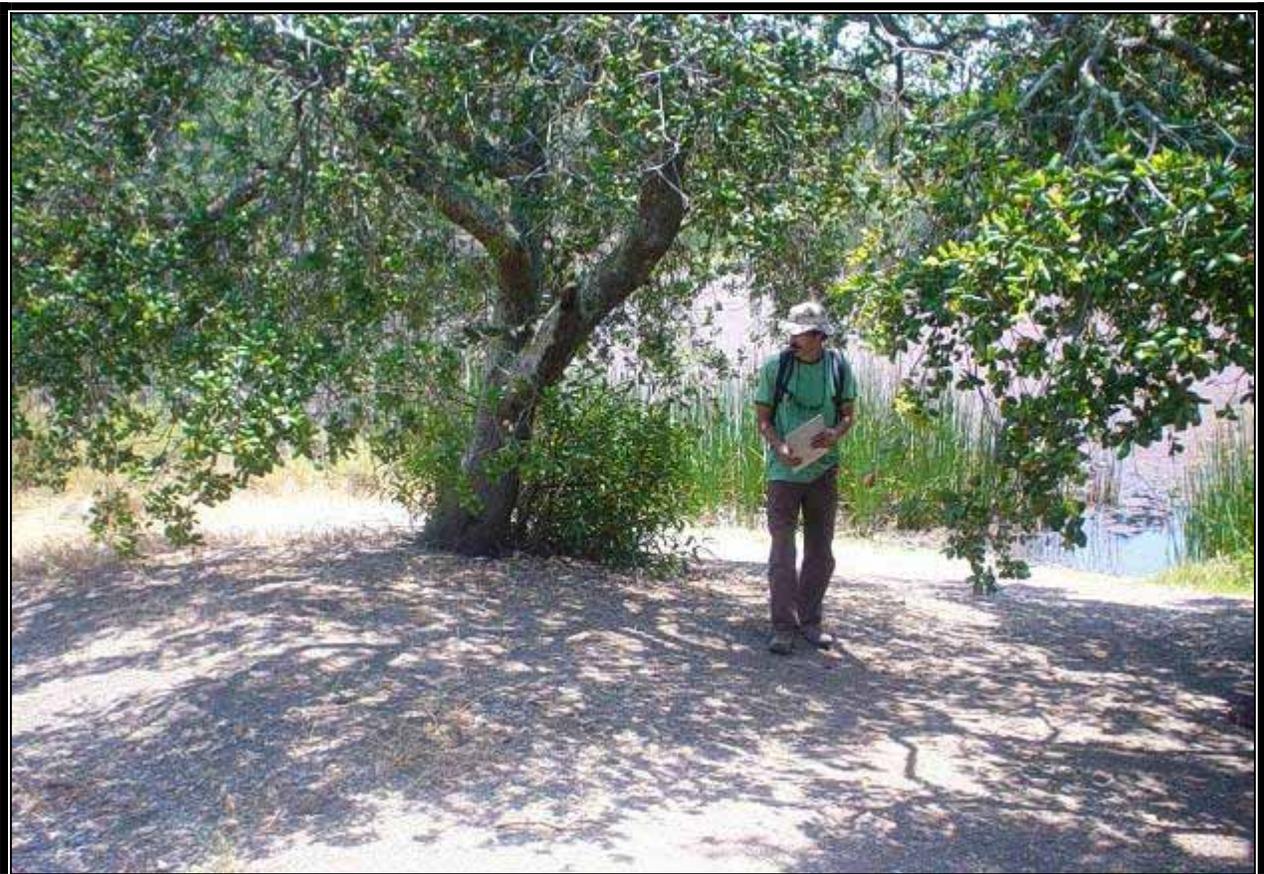
Figure 30. Construction of the second bridge would be completed immediately downstream (to the left) of the current crossing to the creek's tributary.

- **Second Bridge Construction** – A second bridge, extending roughly 14 m (45 ft) in length, would be installed over a side channel of San Nicholas Creek to replace an earthen crossing which currently encroaches into the drainage (Figures 10, 14, 19, and 30).

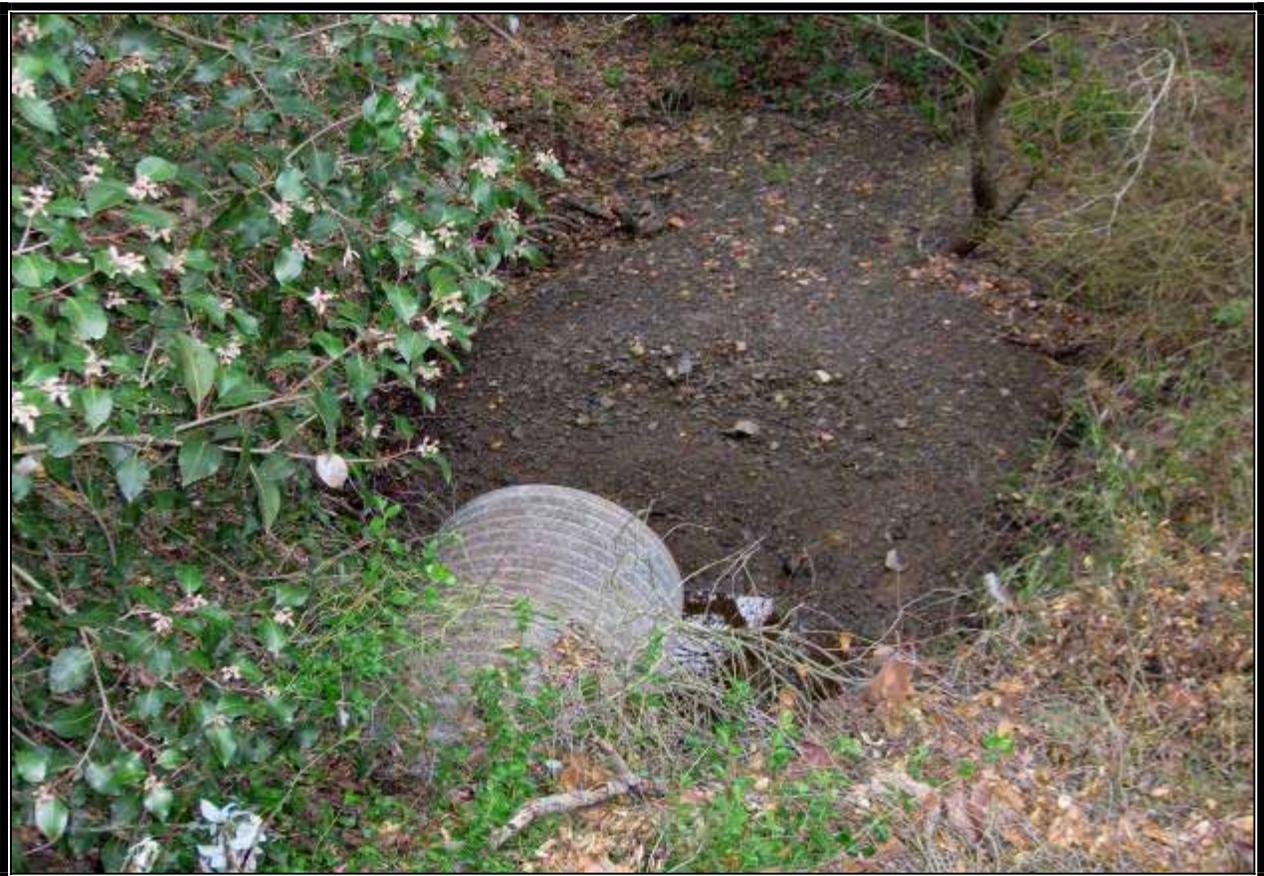
Figure 32. View of habitat conditions within San Nicholas Creek, immediately upstream of the culvert crossing.
