APPENDIX B
NATURAL ENVIRONMENT STUDY REPORT

Natural Environment Study Report

Nicholas Pond Trail ADA Improvement Project

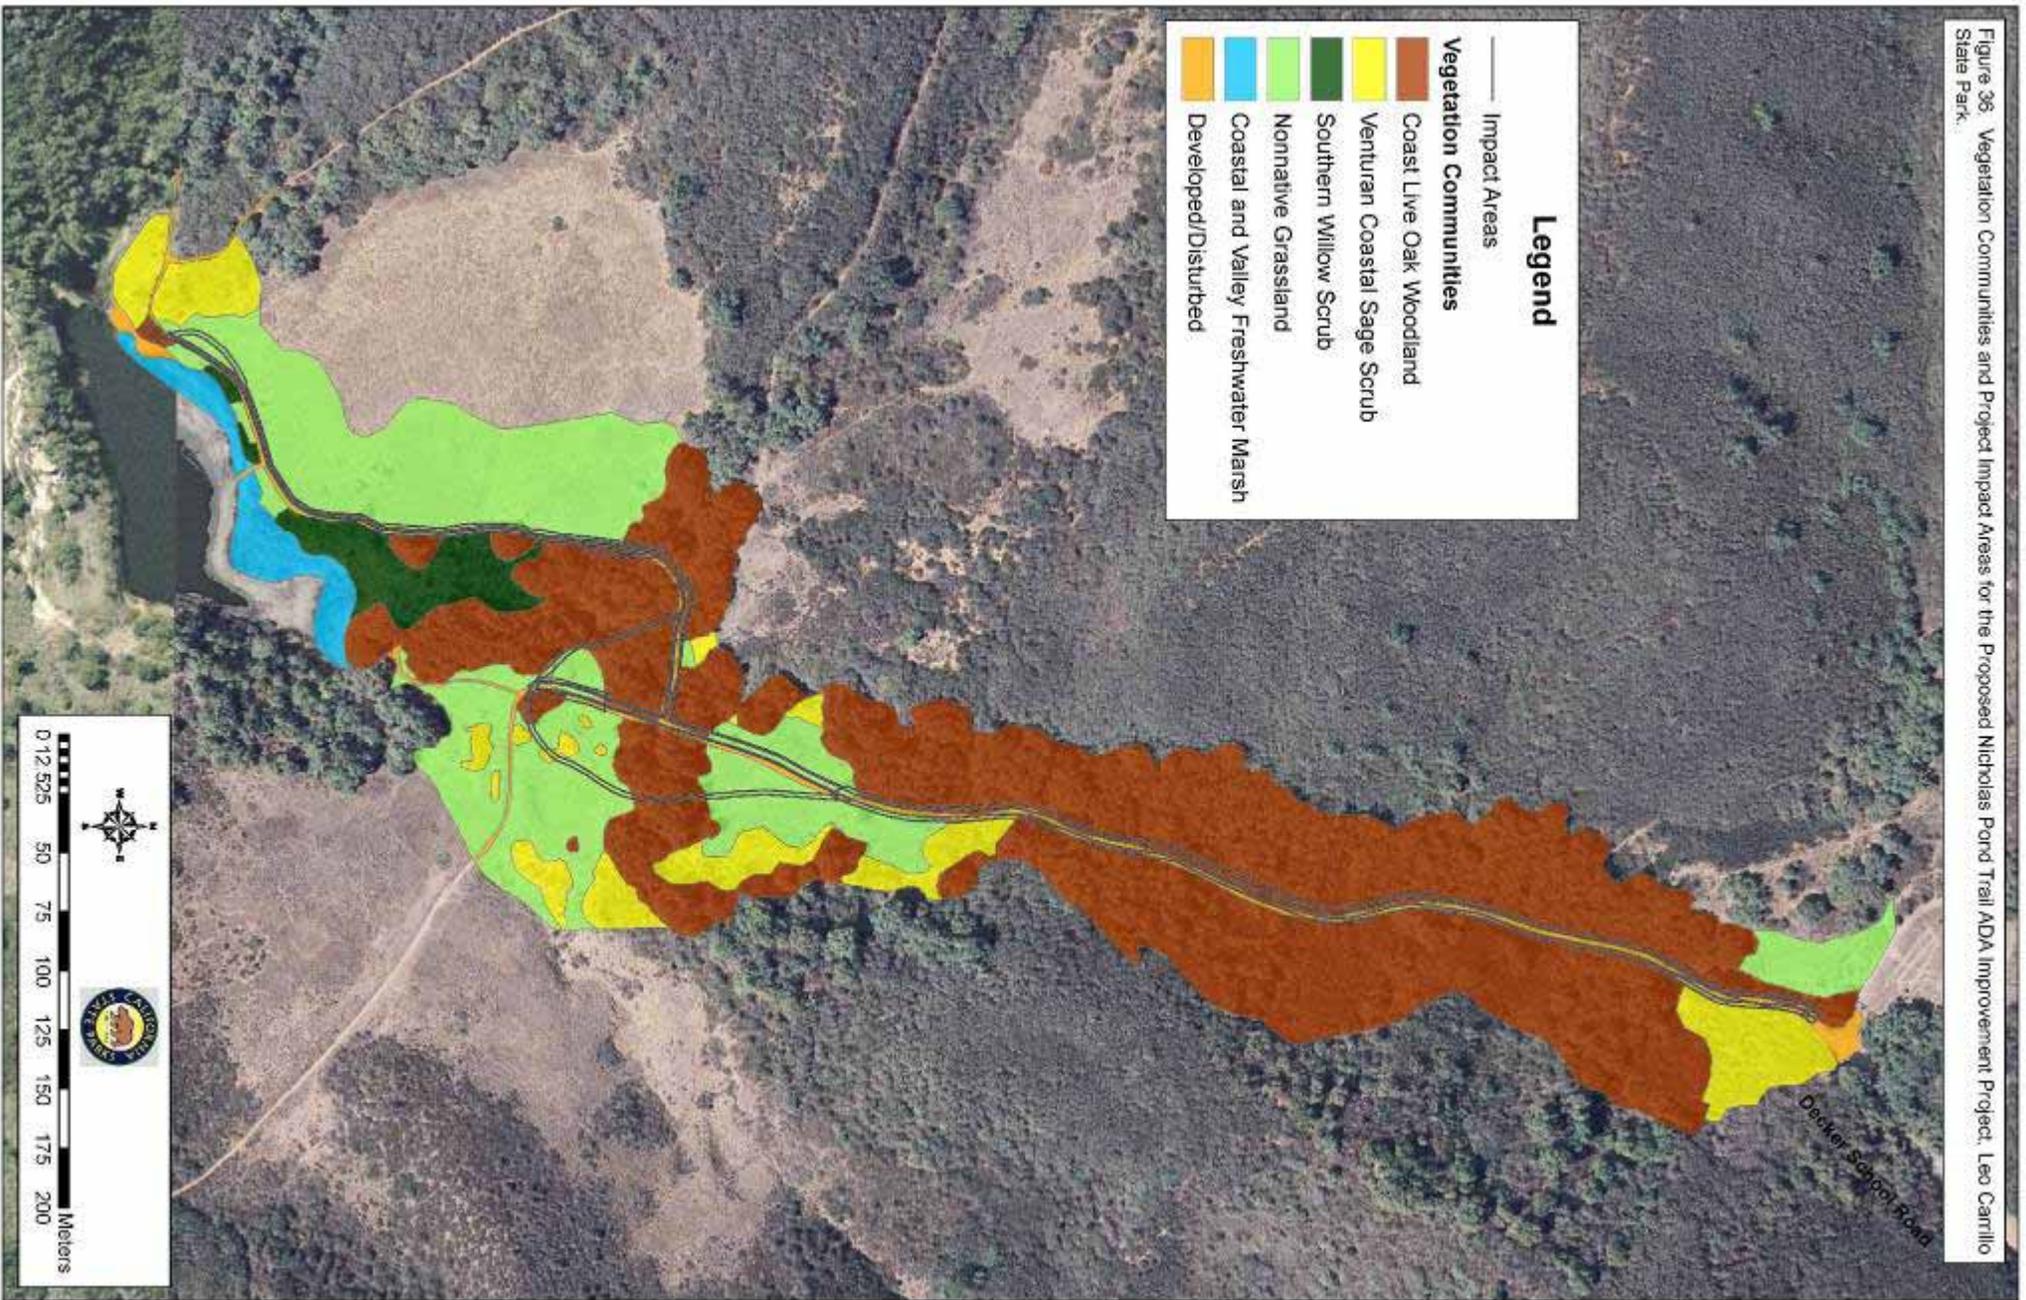
Figure 36. Vegetation Communities and Project Impact Areas for the Proposed Nicholas Pond Trail ADA Improvement Project, Leo Carrillo State Park.

As estimated, project activities would cause the permanent loss of 0.0247 ha (0.0610 ac) of coast live oak woodland, with disturbance primarily resulting from construction of the bridge abutments, the pond overlook, and some small trail reroutes (Table 4, Figure 36). Temporary impacts to 0.2494 ha (0.6157 ac)
